Plumbing Systems Review:

The following report is the result of a site visit by Tim Kehoe of Muermann Engineering, LLC that occurred on October 17, 2014. Site observations and interviews with staff were all used in the preparation of this report.

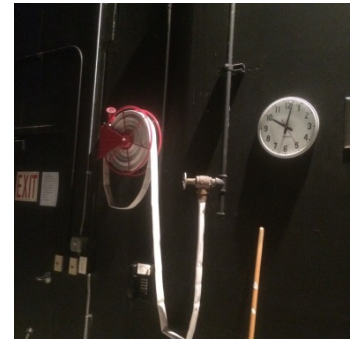
- A. The existing water service for the building is 6" in diameter with a 4" water meter and a 4" domestic water service for the building.
- B. The water piping appears to be adequately sized for the domestic water load of the building. Water pressure appears to be adequate.
- C. Existing water piping is type "L" copper tube and is in good condition.
- D. The existing building has a 6" service for fire protection however the only space that has fire protection is the Auditorium. The existing service is large enough to accommodate fire protection for the entire building.

- A. The facility should evaluate the possibility of expanding the fire protection system throughout the entire building.

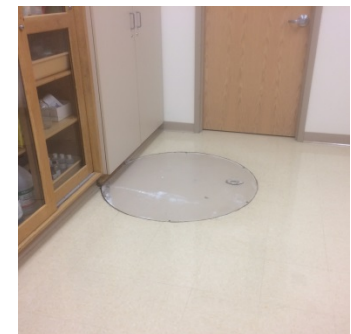
- A. The existing sanitary piping is in good condition. The owner stated that there was no problem with the existing system.
- B. The main cooking for the high school is done the middle school. The kitchen in the high school does not have a grease interceptor and is not required to have one.
- C. Science rooms are in good condition. Acid neutralization basins are located on the first floor and are regularly maintained.

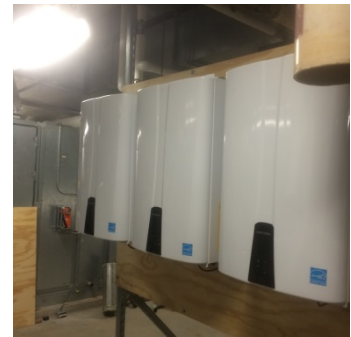
- A. The water heater equipment recently failed and has been replaced with new instantaneous gas fire water heaters manufactured by Navien. The water heaters are energy efficient and in conjunction with the existing hot water storage tank and appears to be adequately sized for the building.
- B. The existing water softener is in good condition and appears to be adequately sized for the building.
- C. See additional comments regarding the air compressor located in the Middle School report.
- D. Welding equipment for the metals shop is located on portable tanks. It was indicated this equipment is operating well.

- A. Instantaneous water heaters require cleaning of the heating element. We recommend annual maintenance checks on this equipment.
- B. Schedule air compressor for replacement.

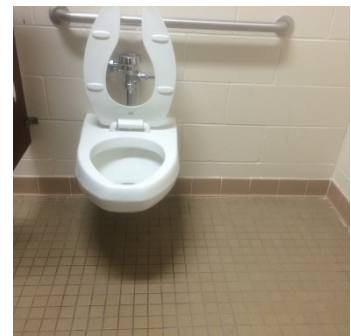
- A. Toilet rooms are ADA compliant.
- B. The water closets and urinals are both flush valves and are in good condition.
- C. Lavatory fixtures are wall hung and are in good condition.

- D. Science room sinks are in good condition. Gas turrets are located in all science rooms and all Science rooms are provided with an emergency shut off valve for the natural gas. Not all of the Science rooms have emergency eye-wash fixtures located within the room.
- E. The metals and wood shops do not have an emergency eye-washer located in the rooms. The wash fountains are old and appear to be in poor condition.
- F. Showers and Locker room fixtures are in good condition.
- G. The school has multiple styles for electric water coolers. Many of these units are not ADA compliant however we feel the building does have enough ADA compliant fixtures to comply with current codes.
- H. The existing laundry is in good condition.

- A. Provide emergency eye-wash fixtures in all science rooms, the metals shop and woods shop.
- B. Provide continual maintenance on all flush valves for flush valves serving water closets and urinals.
