Plumbing Systems Review:

The following report is the result of a site visit by Tim Kehoe of Muermann Engineering, LLC that occurred on October 17, 2014. Site observations and interviews with staff were all used in the preparation of this report.

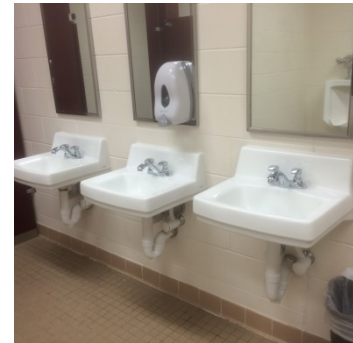
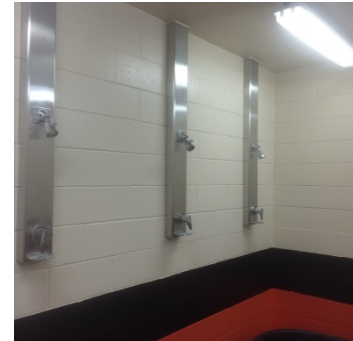
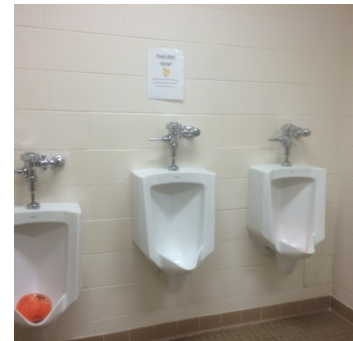
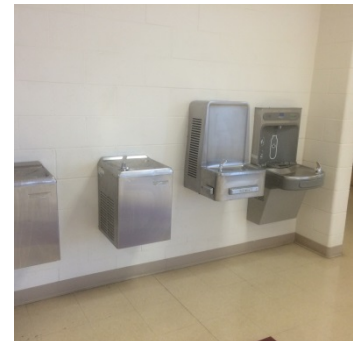
- A. Toilet rooms are ADA compliant.
- B. The water closets and urinals are both flush valves and are in good condition.
- C. Lavatory fixtures are wall hung and are in good condition.

- D. Science room sinks are in good condition. Gas turrets are located in all science rooms and all Science rooms are provided with an emergency shut off valve for the natural gas. Not all of the Science rooms have emergency eye-wash fixtures located within the room.
- E. The metals and wood shops do not have an emergency eye-washer located in the rooms. The wash fountains are old and appear to be in poor condition.
- F. Showers and Locker room fixtures are in good condition.
- G. The school has multiple styles for electric water coolers. Many of these units are not ADA compliant however we feel the building does have enough ADA compliant fixtures to comply with current codes.
- H. The existing laundry is in good condition.

- A. Provide emergency eye-wash fixtures in all science rooms, the metals shop and woods shop.
- B. Provide continual maintenance on all flush valves for flush valves serving water closets and urinals.
